Heramba Chandra College & Sivanath Sastri College

Green Audit- Management Summary

Project Title Assessment of Environmental performance
as per ISO 14001:2015

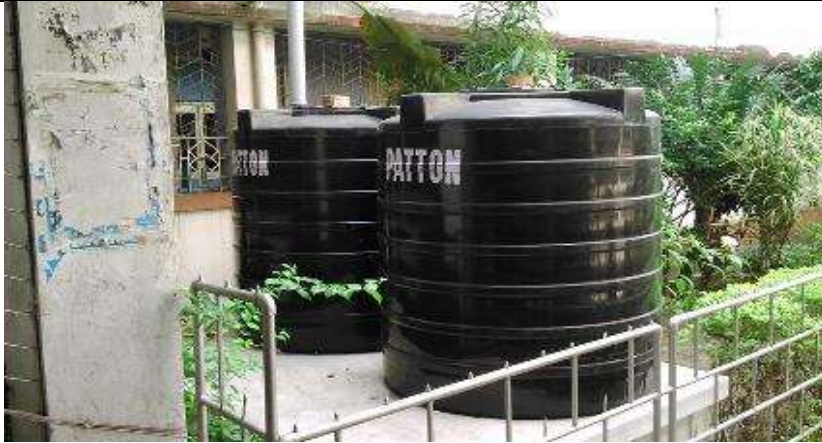
Rainwater harvesting project

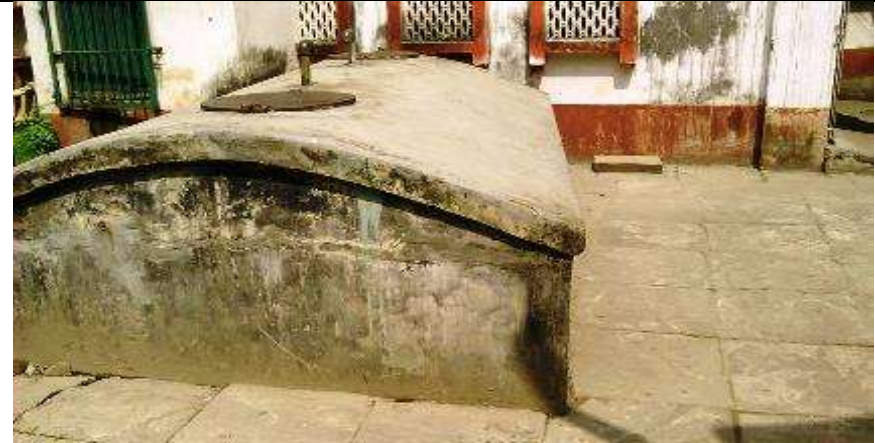
Covered underwater storage tank

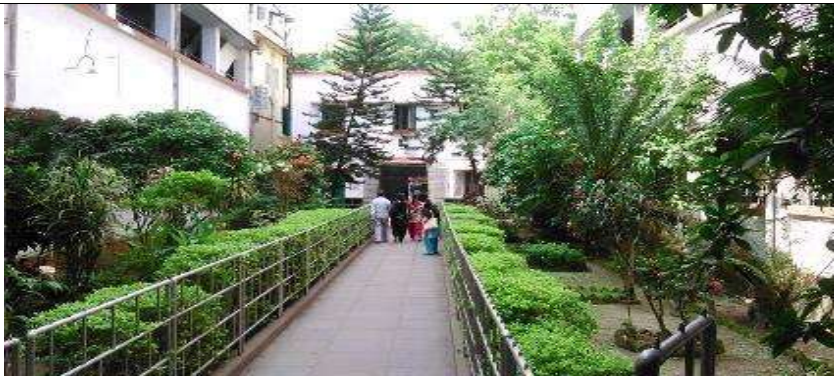
Greenery in the institute courtyard

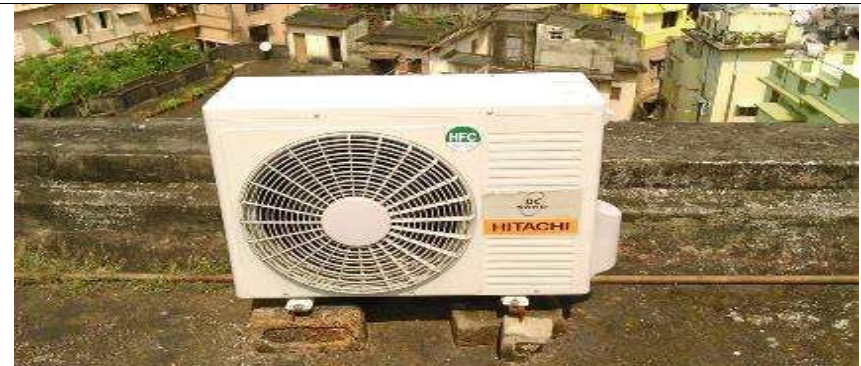
- E-waste generated from office and IT labs are handled through service provider.
- New generation of Air conditioners are observed. They are using the use new generation coolant HFC R401A which creates lead impact on the environment.

Use of new generation Air conditions with HFC R401A coolant

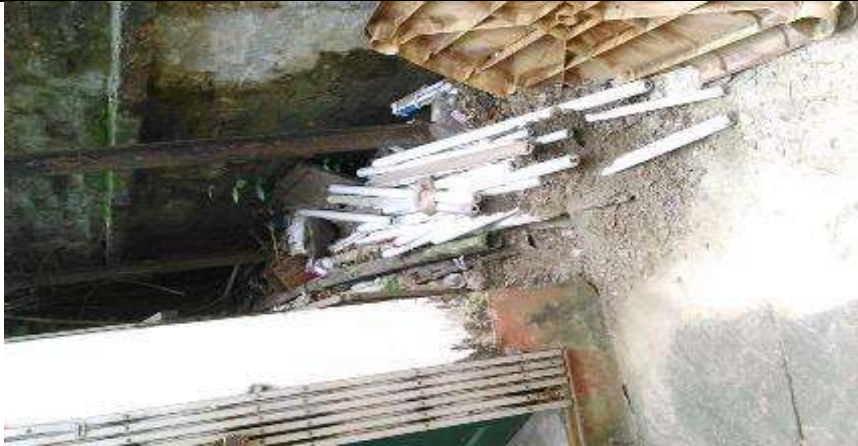
- Various wastages like used tube lights, plastic bottles were observed on ground behind the common room. Organization needs to prepare & implement a waste handling & disposal procedure with clear identification for different type of wastes. Disposal area for different types of waste needs to be earmarked.

Exhibit 1 - Improper damaged tube light storage facility

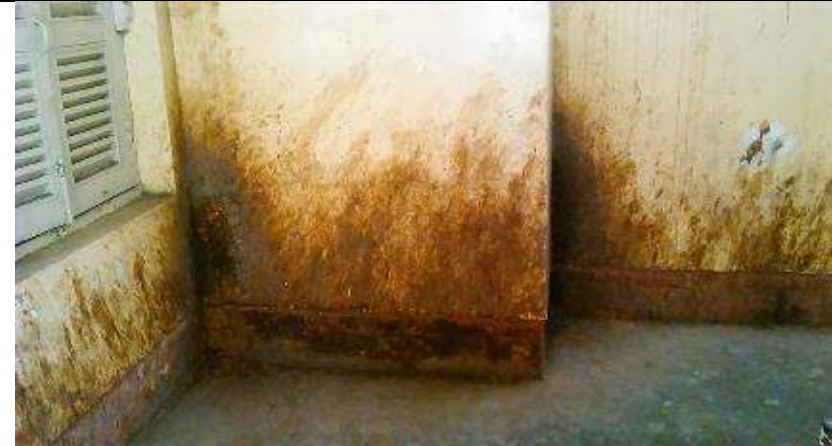
- The cleanliness of the common room for students and some of the classrooms found inadequate. Some of the walls of the common room found in unhygienic condition. (Refer exhibit 2)

Exhibit 2 - Unhygienic condition in common student room

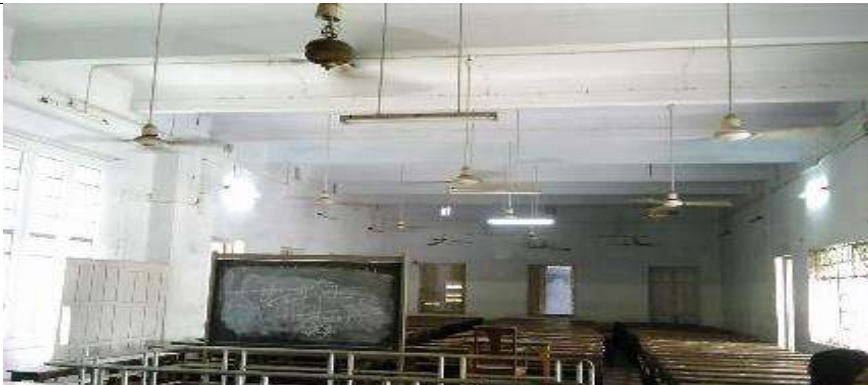
- The communication process for awareness in relation to energy conservation found inadequate. Electrical fans and lights found in use in the unoccupied classrooms and other areas during the day of assessment. (Refer exhibit 3)

- Organization needs to evaluate power usage efficiency by suitable measurement & monitoring of (a.) total connected load segregated in lighting, AC, fans & other utilities (b.) developing operational controls to switch off lights, fans & ACs when rooms / classrooms are unoccupied. Many classrooms found unoccupied while fans & lights operational. Automation / time control mechanism may be explored.

Exhibit 3 - Energy loss (Fan & lights running in empty room)

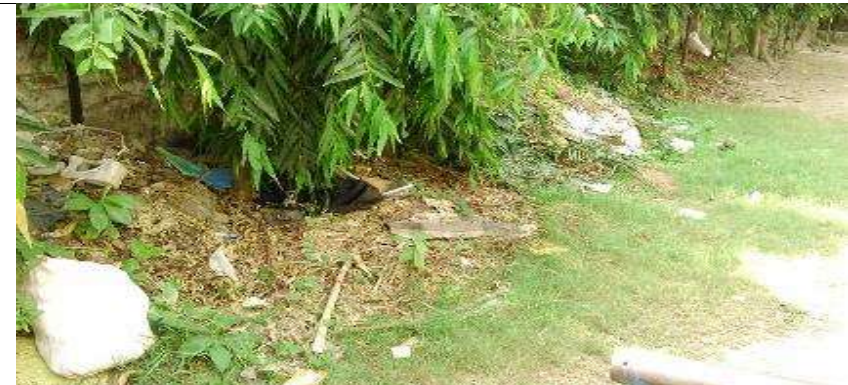
- The organization does not having a waste collection system with proper segregation. The organization may introduce waste collection bins with different colour code for biodegradable and non-biodegradable waste for source segregation with adequate signage

Exhibit 4 - Ineffective solid waste management

- The organization may start proper communication with the local Municipal Corporation for regular collection of solid waste from the campus. (Refer exhibit 4)

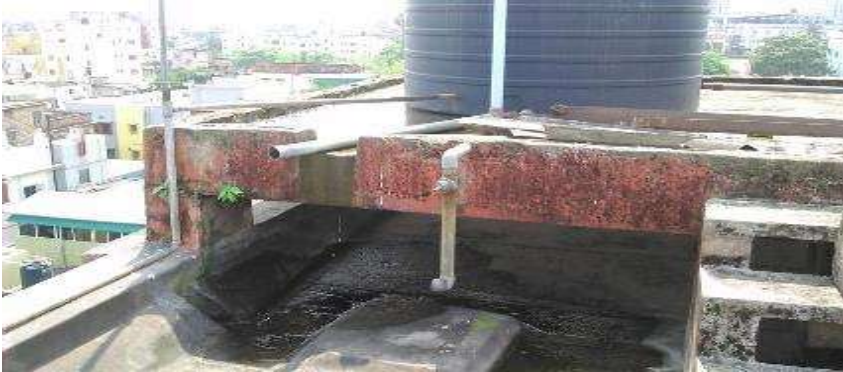
Exhibit 5 - Roof top water tank overflow spillage

- Organization needs to evaluate its' water consumption efficiency by suitable monitoring of (a.) input from KMC (b.) Quantity of water supplemented by rain water harvesting which is under implementation (c.) operational control to reduce wastage in toilets & canteens , (d.) identification & stoppage of leakages in pipelines. Float valve operated auto shut off switch may be installed for pump sets used for overhead tank filling. (Refer exhibit 5)

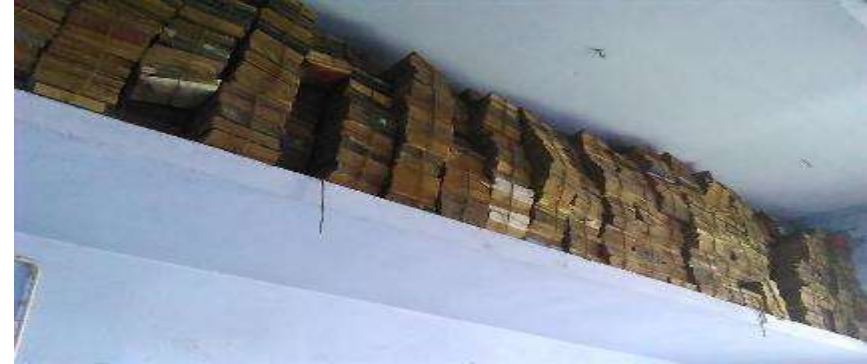
Exhibit 6 - Old stock of unused books inside classroom thereby increasing fire load

- Organization needs to develop an emergency preparedness plan.
- Signages indication emergency evacuation layouts, routes and assembly area are not implemented.
- Stakeholder awareness on emergency preparedness needs to be improved.
- Infrastructure for fire fighting needs to be reviewed.
- First aid room is not maintained in proper condition. (Ref exhibit 7)
- Unwanted stock of inflammable materials needs to be disposed off (Refer exhibit 6)

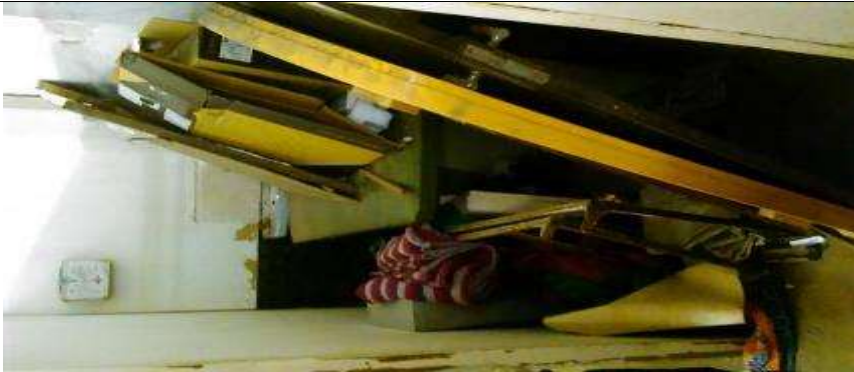
Exhibit 7 - Improper maintenance of first aid room

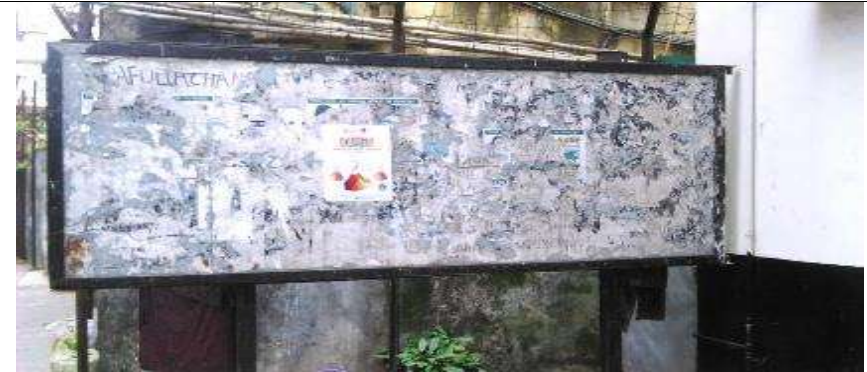
Exhibit 8 - Notice board can be effectively used to create awareness

- Suitable communication by means of banner, posters, one point lesson can be displayed at vantage location to create awareness among all stakeholders. (Refer exhibit 8)
